THICKENER/FLUID INTERACTION IN LUBRICATING GREASES

INTERIM REPORT
AFLRL No. 173

U.S. Army Fuels and Lubricants Research Laboratory
Southwest Research Institute
San Antonio, Texas

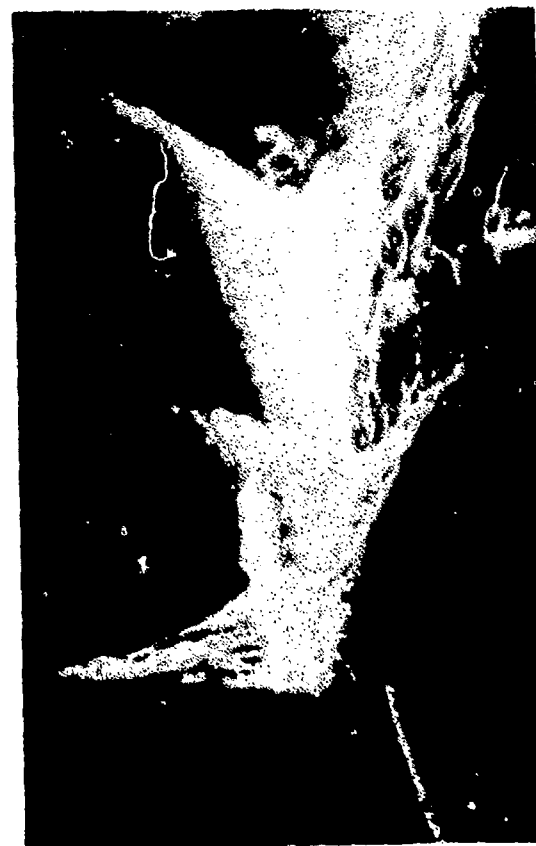
a. 500X

b. 5000X

20,000X

FIGURE 1. SCANNING ELECTRON MICROSCOPE PHOTOGRAPHS OF GLASS MICROBEADS WITH THICKENER

Glass microbeads 37 micrometers in diameter were selected as the supporting media, and grease containing lithium 12-hydroxystearate as thickener was chosen for extraction. Loading ratios were chosen to produce coating thicknesses of 0.4 percent, 4 percent, and 40 percent of thickness to bead diameter. The base oil was extracted from the mixture using n-heptane in a soxhlet extractor. The extracted oil was recovered for future use, and the glass microbeads with thickeners were tumbled and dried in a rotary evaporator. Although this technique produced encouraging results, it obviously needed refinement since the coatings were somewhat uneven and had a tendency to peel away from the microbead as shown in Figure 1. At the high magnification of Figure 1(c), individual strands of the coating could be distinguished with the characteristic twisted appearance that had been noted in earlier work.^(5-7,12-14) The areas of the microbeads that were heavily coated appeared to be a tightly compacted mat of fibers.

In an attempt to produce a more evenly distributed coating on the microbeads, the grease was prediluted with n-heptane before the microbeads were mixed into the grease. The mixture was then placed in the soxhlet extractor and the oil removed using n-heptane. After using this approach with a variety of loading ratios, scanning electron microscope examination of the coated beads determined that only very low-loading ratios (<4 percent) could be evenly applied using this technique. All attempts at higher loading ratios produced uneven coatings with a tendency to peel away from the beads, similar to the condition shown in Figure 1.

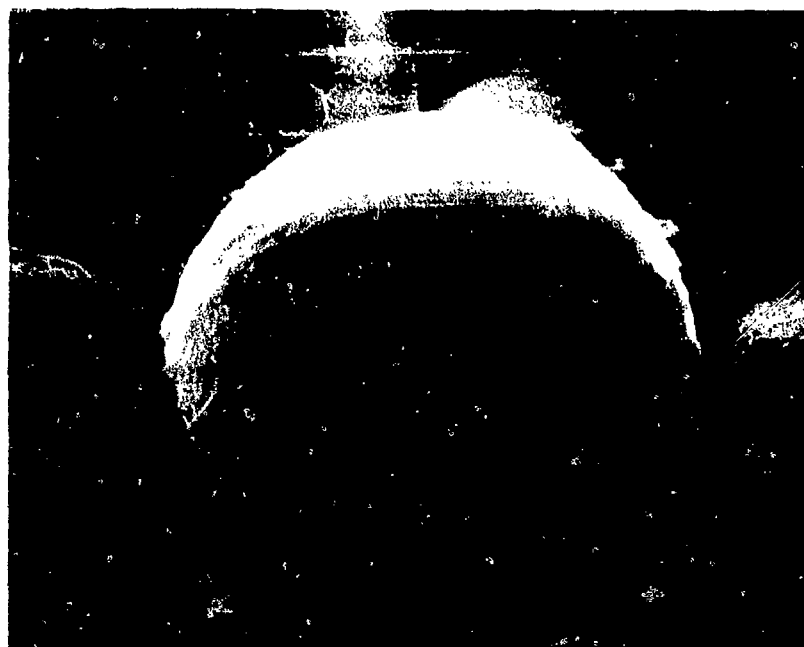
FIGURE 3. MICROBEADS PREPARED FOR HPLC COLUMN PACKING USING
FREEZE DRYING TECHNIQUE FOR THICKENER COATING (2000X)

It was determined that the interconnecting network of thickener strands between the microbeads could be eliminated by reducing the thickener to microbead-loading ratio and freeze drying the microbead/thickener/solvent mixture prior to column packing. The loading ratio which seemed to work best for the solvent extraction operation was 1 gram of bulk grease to 1 gram of microbeads. Following the freeze drying step, SEM evaluation of the microbeads revealed well-coated microbeads without interconnecting strands, which were suitable for dry packing into HPLC columns, as shown in Figure 3.

The same hydrocarbon compounds were then injected into the thickener-coated microbead column and retention times recorded. The initial results were encouraging in that a slight increase in retention time was noted as compared to the control column. The shift in retention time proved, however, to be the same for all the tested compounds and the base oil. This indicates that the shift in retention time was not due to variation in affinity between the various chain-length hydrocarbon compounds and the thickener. The slight increase in retention time was most likely due to the increased effective surface area of the coated microbeads as compared to the smooth surfaces of the uncoated microbeads.

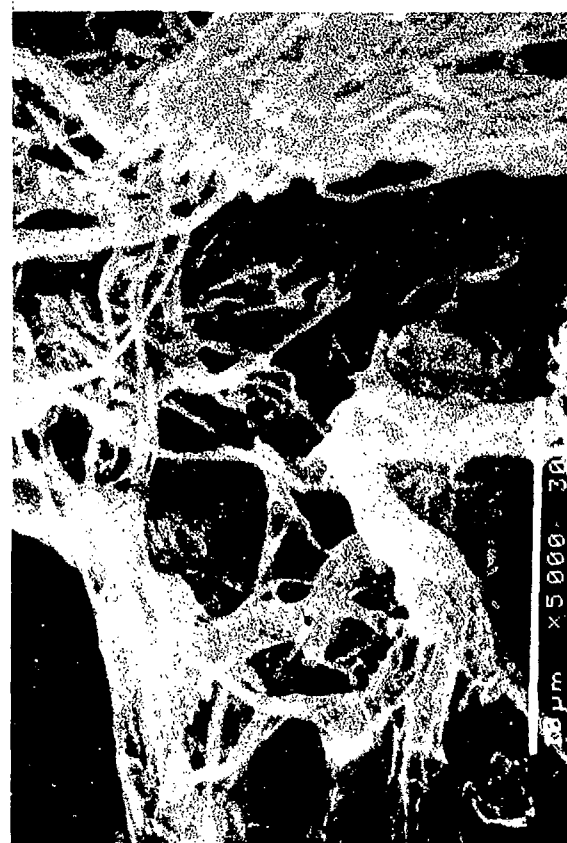
(a) Sample 13 Lithium

(b) Sample 16 Sodium

(c) Sample 21 Ca/Li

(d) Sample 8 Barium

FIGURE 4. SEM MICROGRAPHS OF GREASE THICKENERS -- SAMPLES 8, 13, 16 & 21

While a wide variation in microstructure types was encountered in this program, there were sufficient similarities between calcium, lithium, barium, sodium, and mixed-base greases to allow them to be discussed as a group. Microstructures for this group of thickeners are illustrated in Figures 4 through 13.

One of the more commonly encountered structures within this group of thickeners is the interconnected three-dimensional network of strands shown in Figures 4 through 6. While the size of this matrix seems to vary with thickener type and manufacture, the basic networks are quite similar. Since the photographs presented are quite high in magnification, it is easy to envision that the close spacing of the strands could easily cause entrapment of the oil by mechanical and/or capillary effects in this type of structure. Figures 7 through 13 represent variations from network of strands shown in

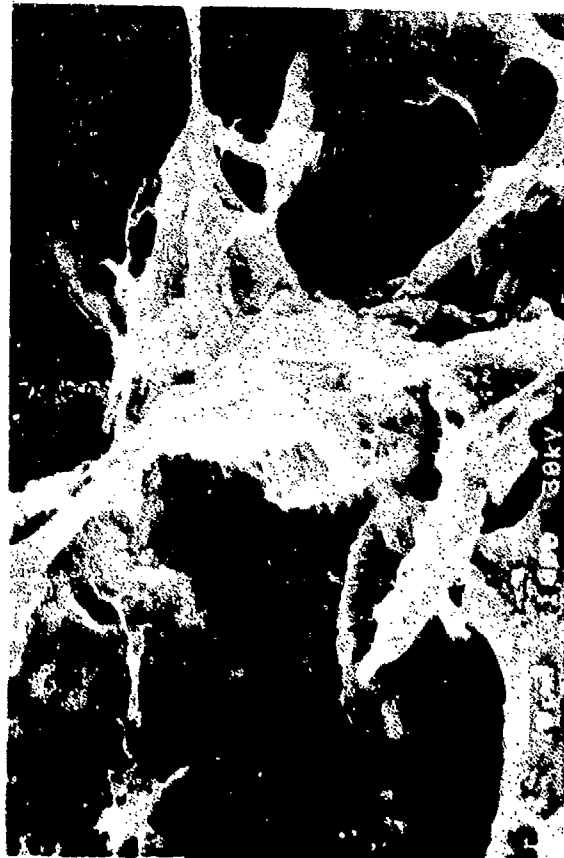
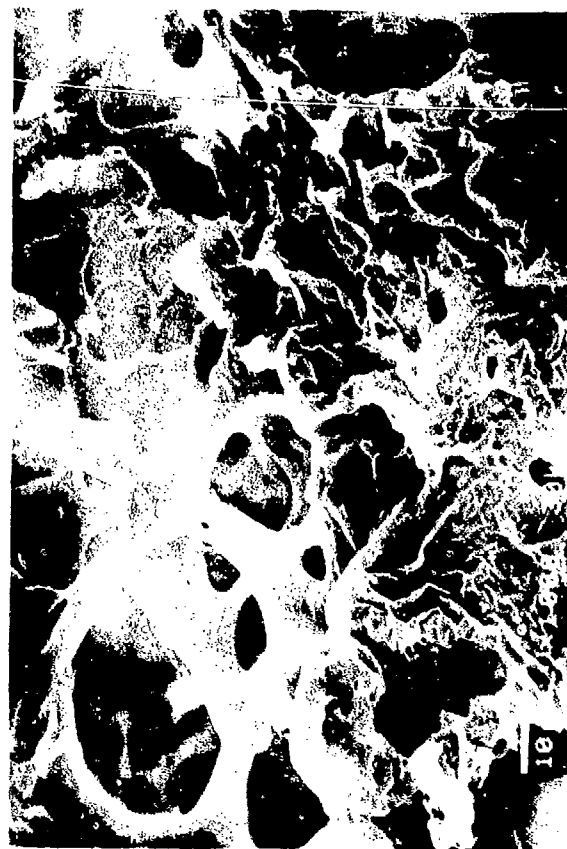
(a) Sample 53 Lithium

(b) Sample 19 Calcium

(c) Sample 6 Barium

(d) Sample 6 Barium

FIGURE 6. SEM MICROGRAPHS OF GREASE THICKENERS -- SAMPLES 6, 19 & 53

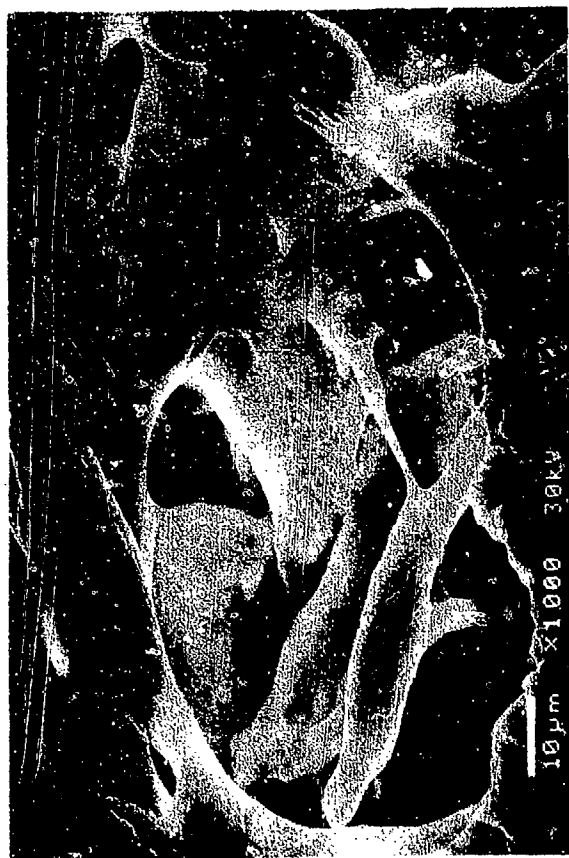
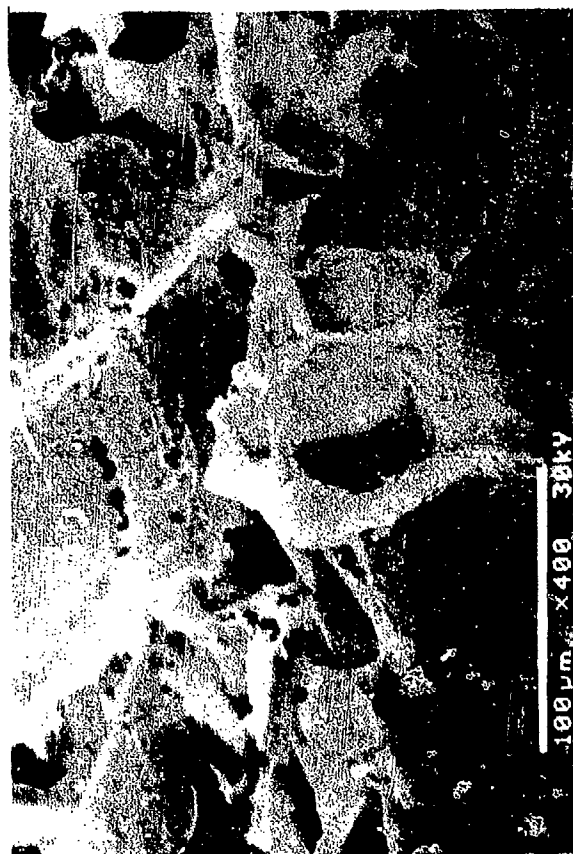
(a) Sample 51 Lithium

(b) Sample 42 Calcium

(c) Sample C61 Li or Ca

(d) Sample 4 Mixed base

FIGURE 7. SEM MICROGRAPHS OF GREASE THICKENERS -- SAMPLES 4, 42, 51 & C61

earlier figures. These structures vary from a lumpy amorphous-looking mass, such as shown in Figures 7(c) and 9(d), to partially resolved networks or compacted strands, such as shown in Figure 8(b) and 8(c). Two of the structures shown from this group are totally different from any of the others. Sample 15 in Figure 13(c) has a short rod-like structure which more closely resembles the polyurea thickeners, and sample 64 in Figure 13(d) more closely resembles the clay type thickeners.

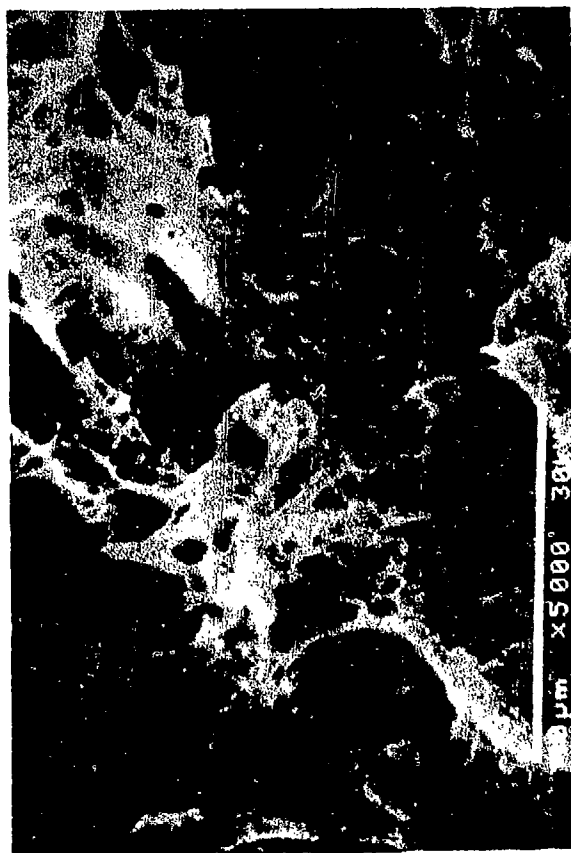
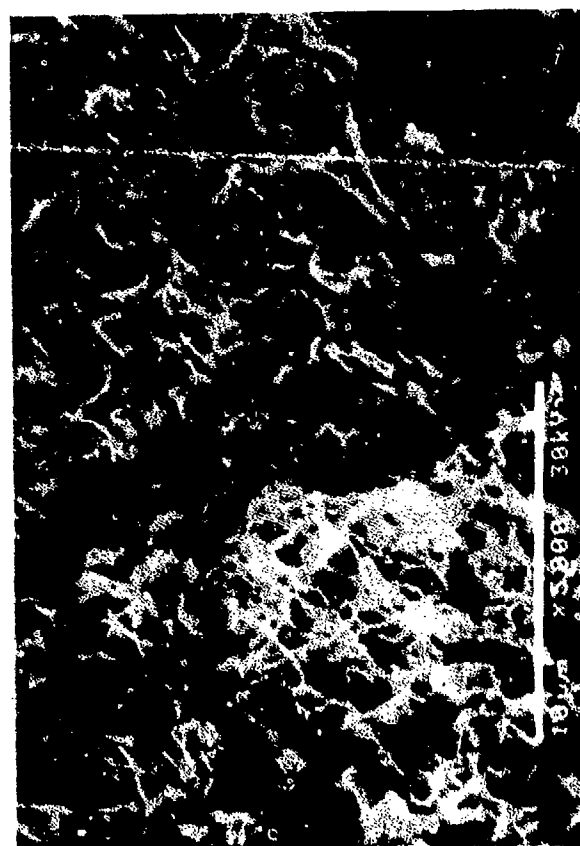
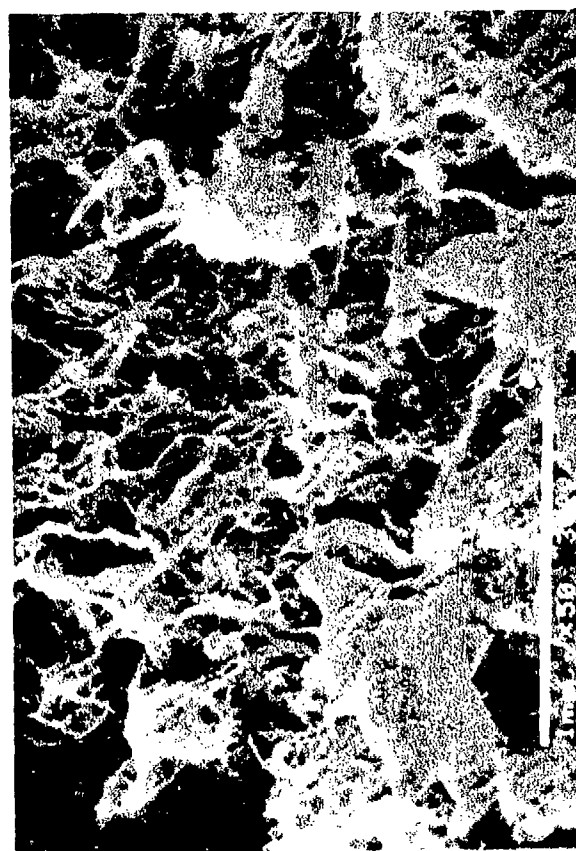
FIGURE 8. SEM MICROGRAPHS OF GREASE THICKENERS -- SAMPLES 3, 22, 23 & 52

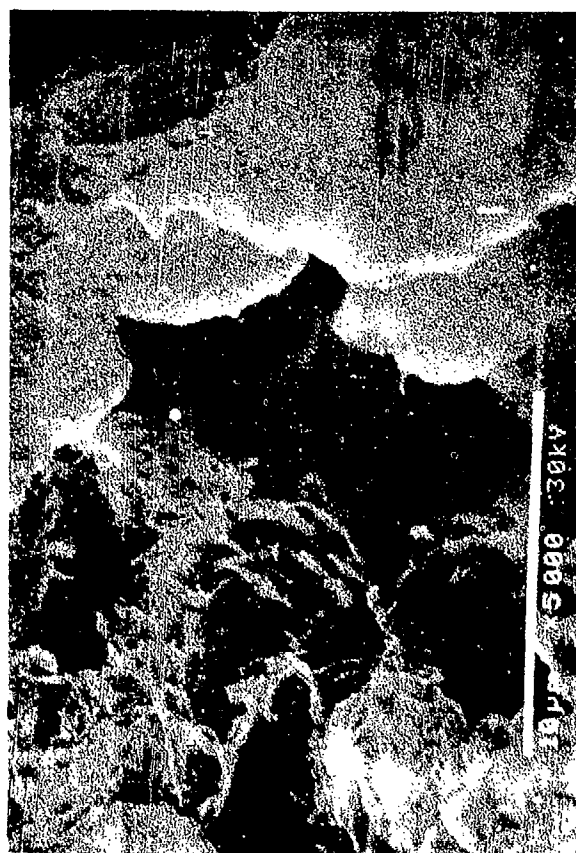
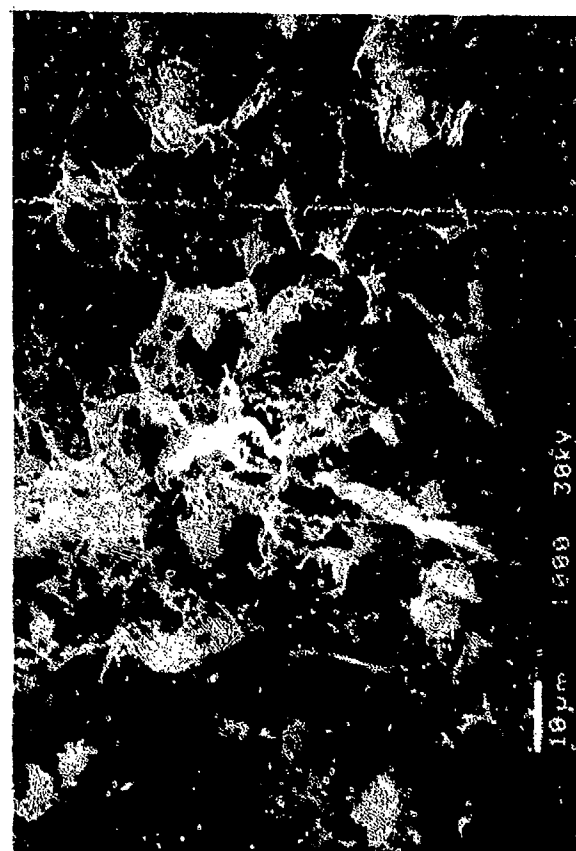
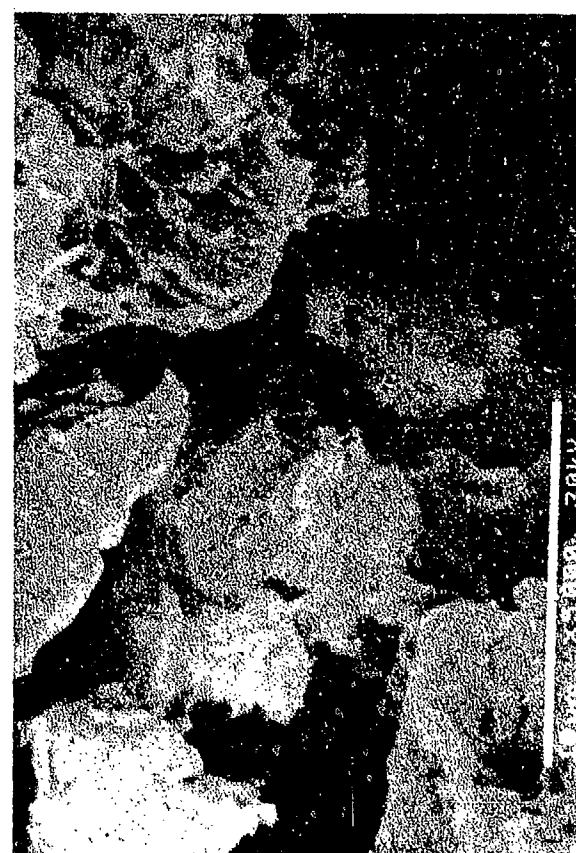
(a) Sample 20 Calcium

(b) Sample 48 Lithium

(c) Sample B61 Li/Ca
Inner bearing

(d) Sample B61 Li/Ca
Outer bearing

FIGURE 9. SEM MICROGRAPHS OF GREASE THICKENERS -- SAMPLES 20, 48 & B61

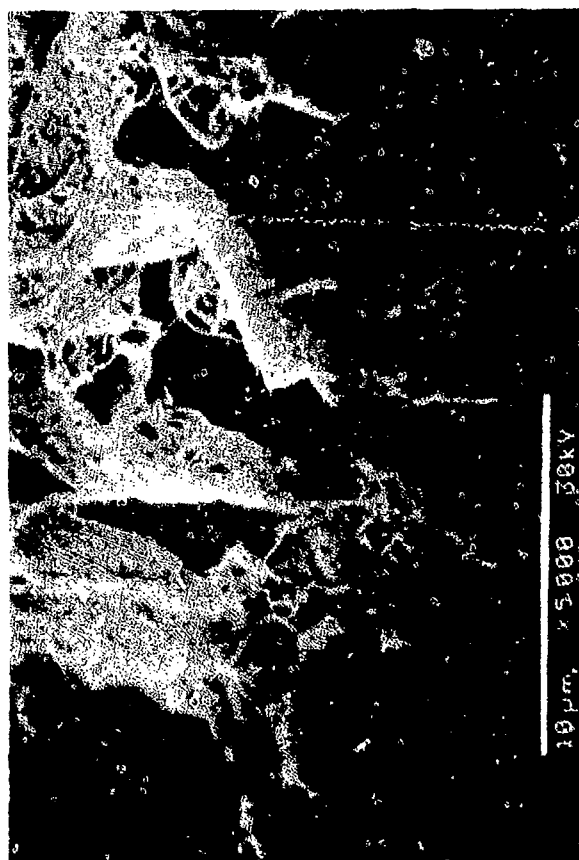
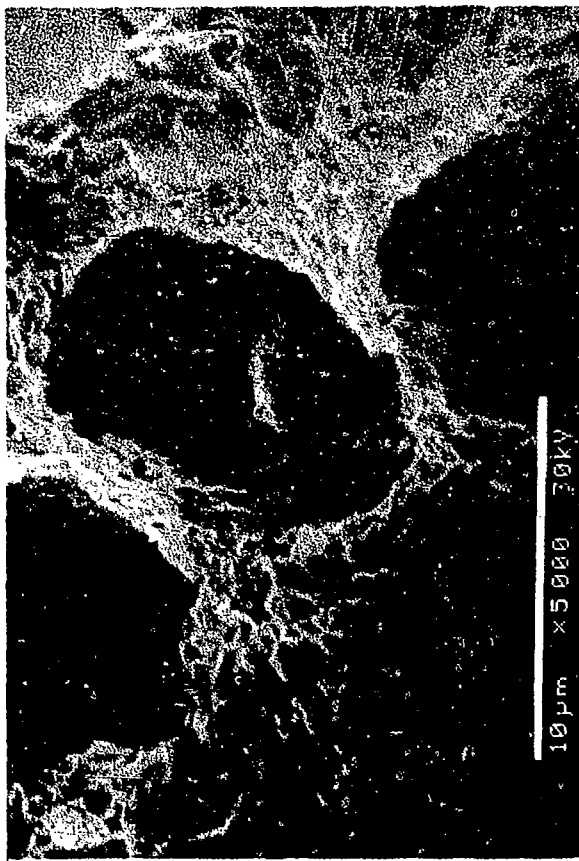
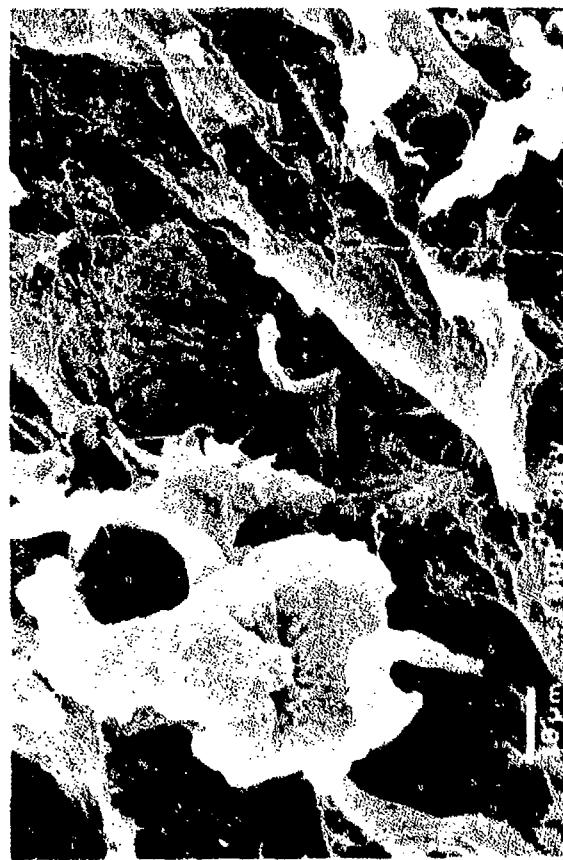
FIGURE 10. SEM MICROGRAPHS OF GREASE THICKENERS -- SAMPLES 2, 19, 49 & B61

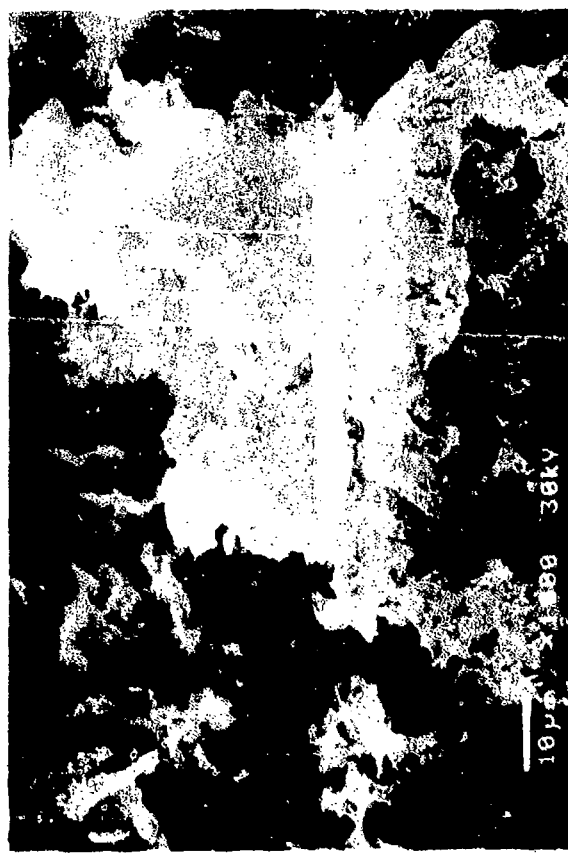
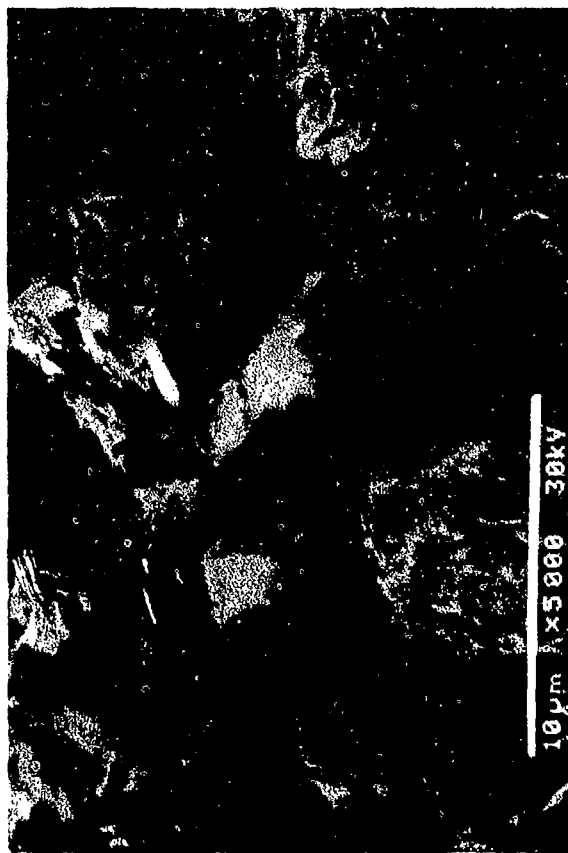
FIGURE 11. SEM MICROGRAPHS OF GREASE THICKENERS -- SAMPLES 5, 33, 35 & 63

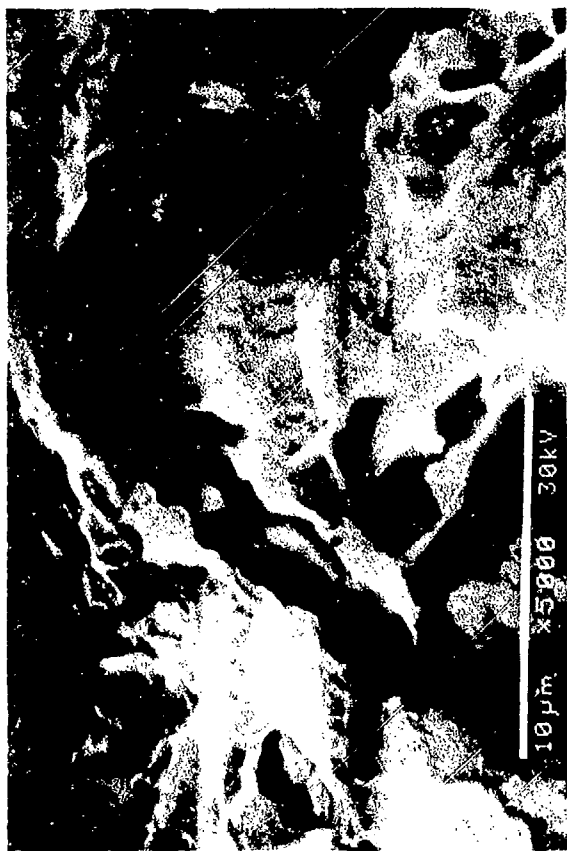
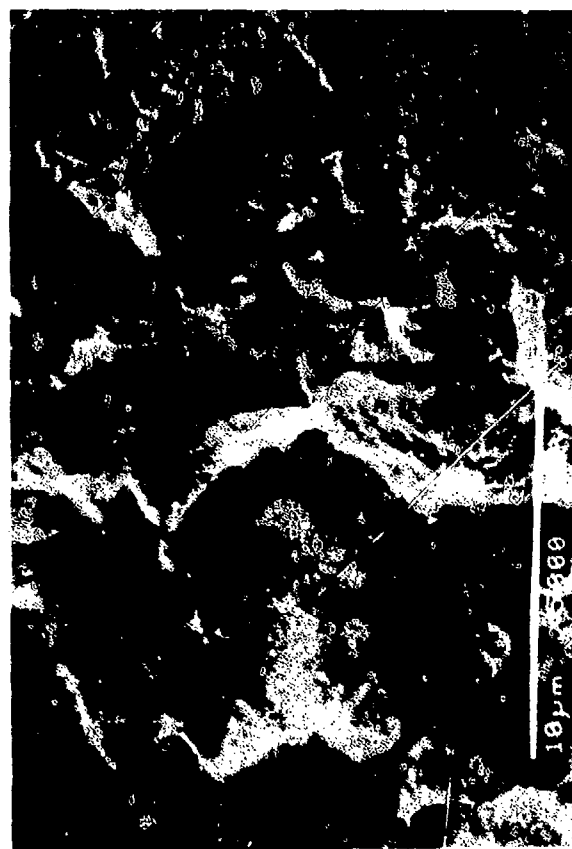
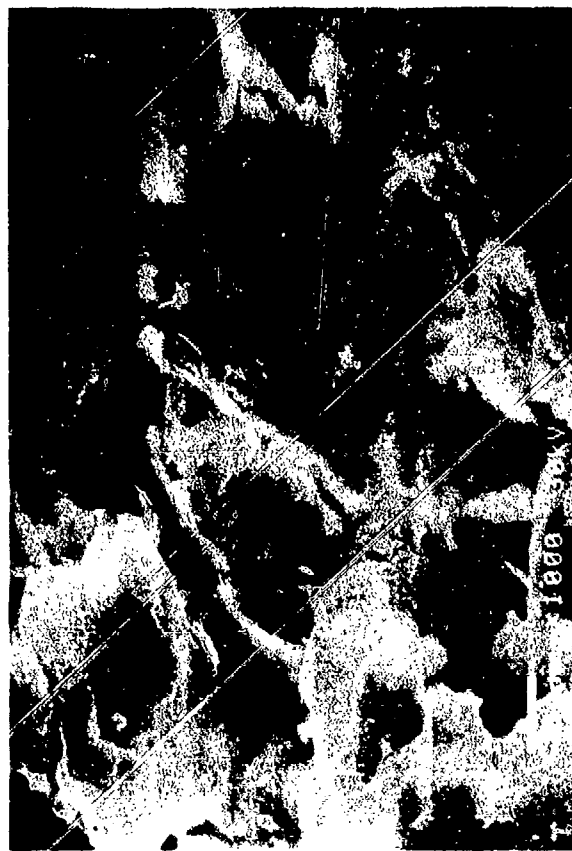
FIGURE 12. SEM MICROGRAPHS OF GREASE THICKENERS -- SAMPLES 29, 34, 39 & 54

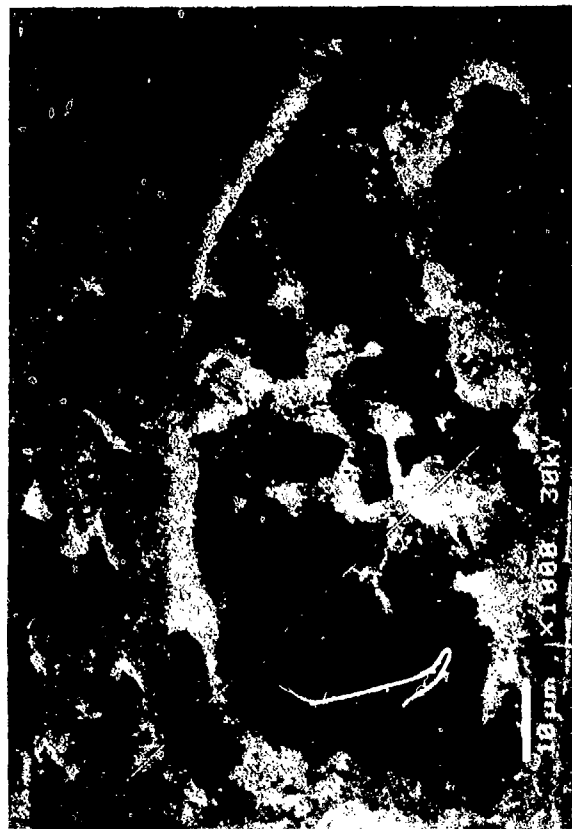
(b) Sample 47 Lithium

(d) Sample 64 Lithium

FIGURE 13. SEM MICROGRAPHS OF GREASE THICKENERS --- SAMPLES 7, 15, 47 & 64

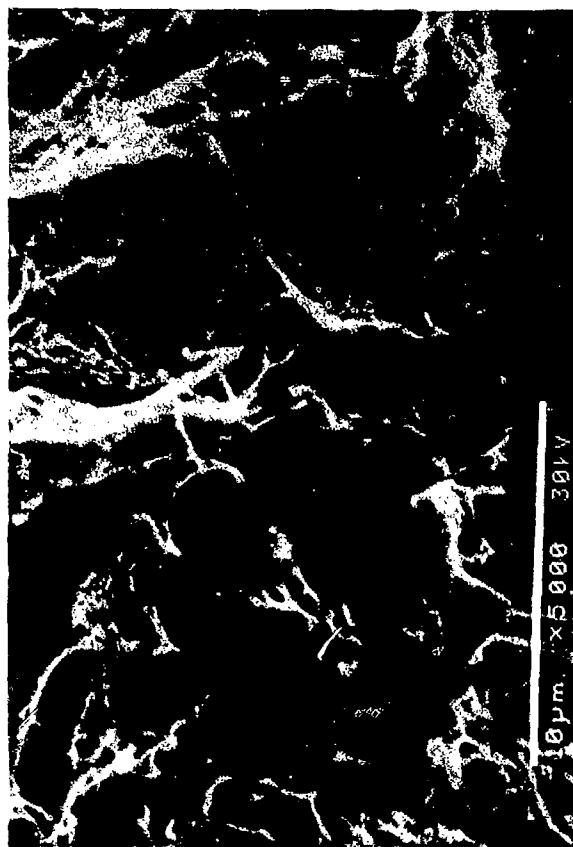
FIGURE 14. CLAY THICKENERS --- SAMPLES 9, 26, 27 & 56

Another group of thickeners examined in this program were the clay thickeners whose microstructures are shown in Figures 14 through 17. The first two microstructures illustrated in this group, Figures 14(a) and 14(b), are somewhat suspect as to whether the identification of them as clays is correct since they possess the strand-like network noted in the earlier group of structures. The majority of the clay microstructures can be described as laminate-appearing platelets, such as in Figures 14(d) and 16(d), agglomerated lump as in Figure 17(a), or a mixture of these two primary microstructures.

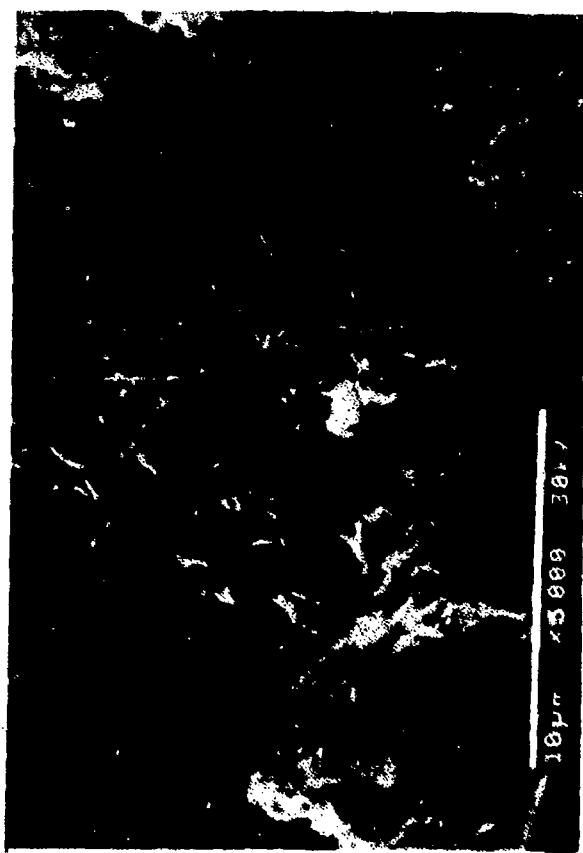
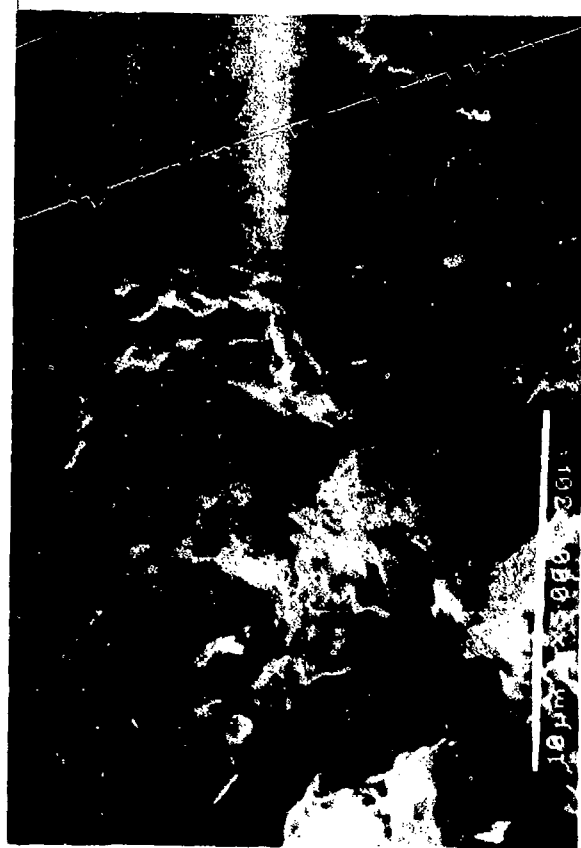
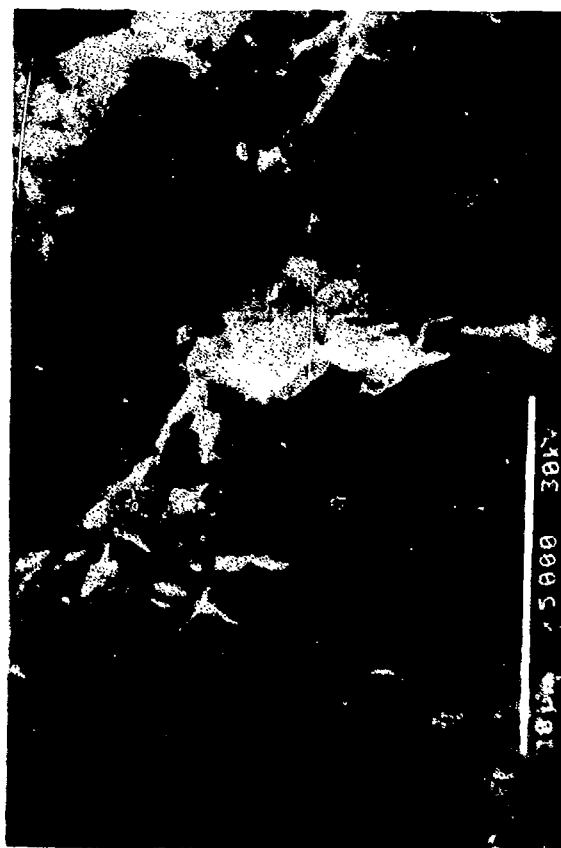
FIGURE 15. CLAY THICKENERS -- SAMPLES 10, 24, 26 & 38

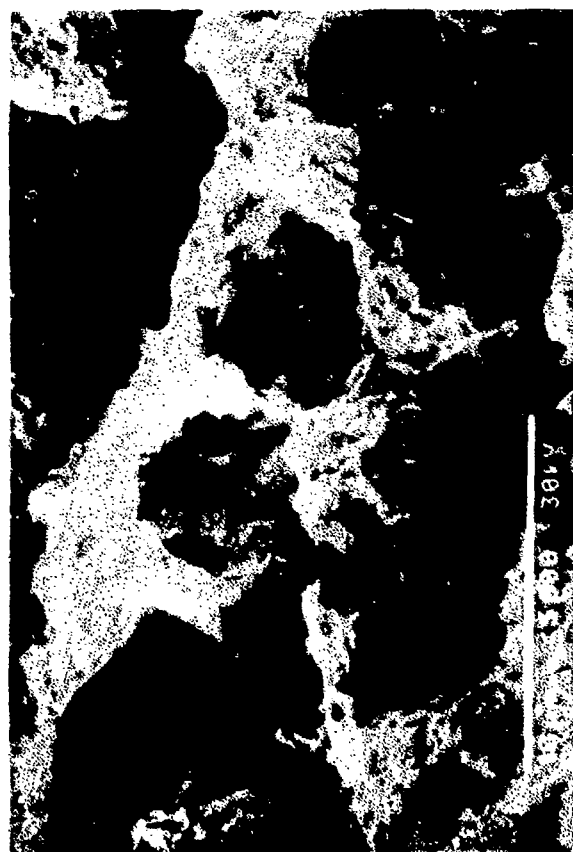
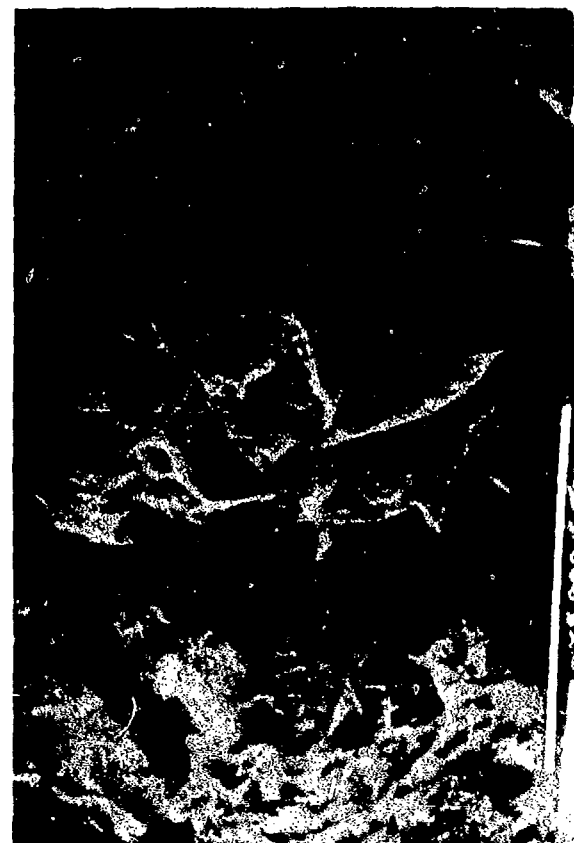
FIGURE 16. CLAY THICKENERS -- SAMPLES 11, 12, 41 & 50

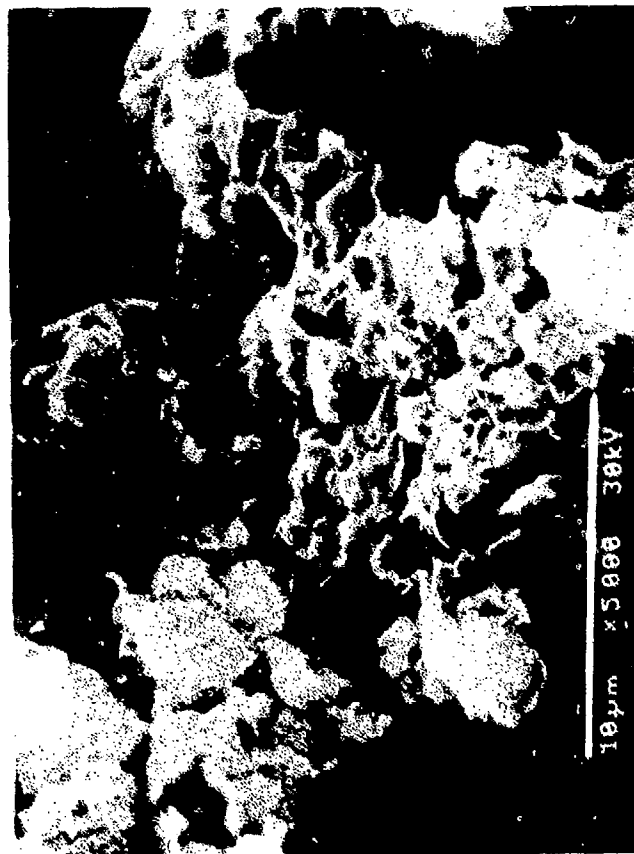
FIGURE 17. CLAY THICKENERS -- SAMPLES 28 & 57

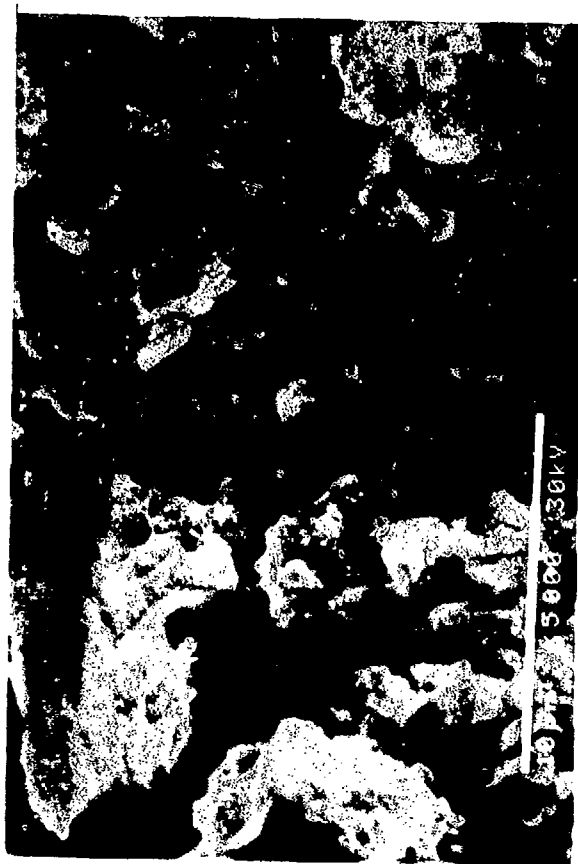
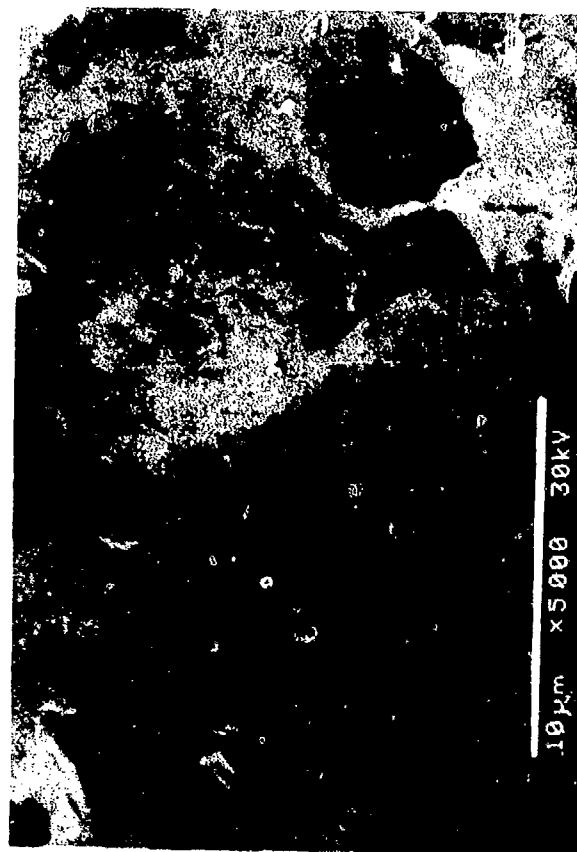
FIGURE 18. POLYUREA THICKENERS -- SAMPLES 1, 14, 45 & 61

A third group of thickener microstructures are the polyurea thickeners. This group showed the widest variation of all thickener types examined. Very little similarity exists between any of the individual samples within this group. The structures for the polyurea-type thickeners are presented in Figures 18 and 19.

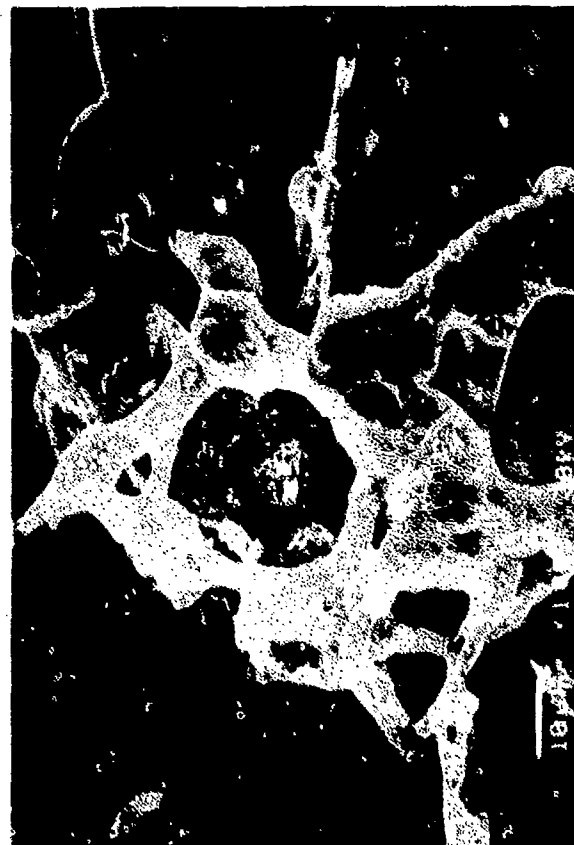
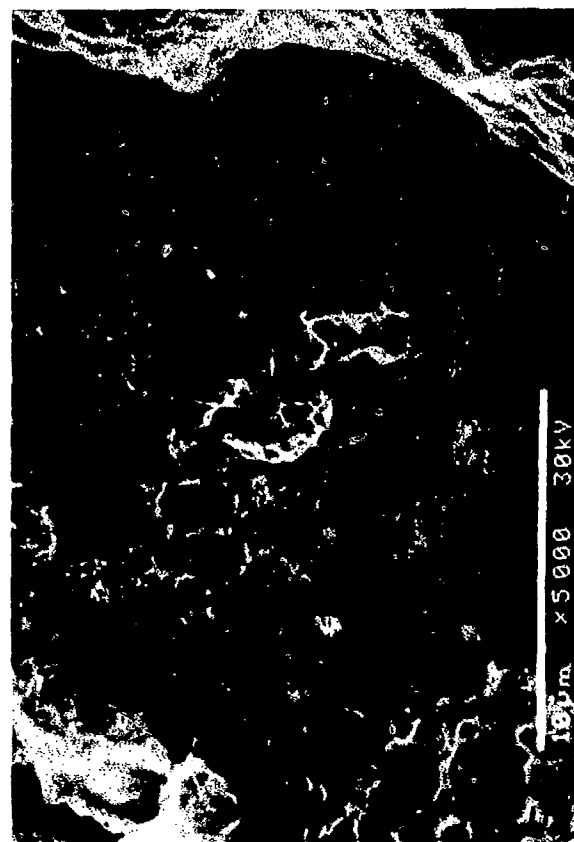
FIGURE 19. POLYUREA THICKENERS -- SAMPLES 30 & A66

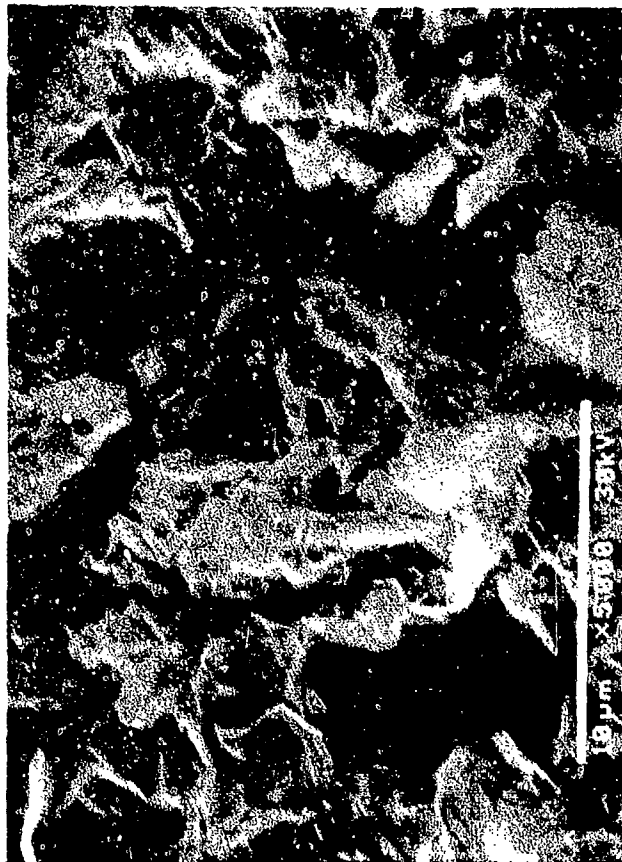
FIGURE 20. MICROGEL THICKENERS -- SAMPLES 18 & 40

The fourth group examined contained only two samples, and Figure 20 represents the two microgel thickeners. It is difficult to comment on these structures since the composition of the microgel is unknown.
